Inspection Report

2287 Waldon Rd
Grand Rapids , MI 49505

1 Report Information

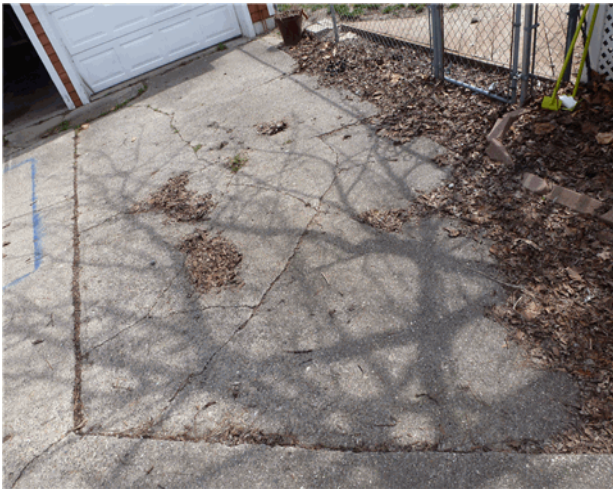
2) Driveway Conditions AS Common cracks and settlement were observed.

Minor cracking and settling in driveway.

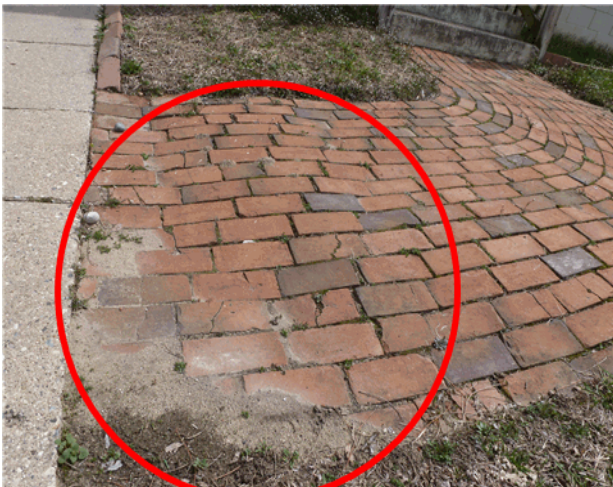
3) Sidewalk Conditions S The front brick sidewalk surface was raised or settled. This may cause tripping hazards. These should be repaired for safety.

Front entry brick sidewalk settling possible trip hazard.

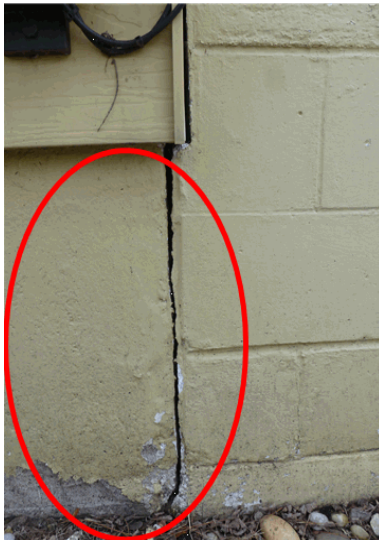
The patio surface was raised or settled causing a minor tripping hazard. These should be repaired for safety. Common settlement type cracks were observed to the porch. Minor settlement was observed at the porch. Although no immediate concern was observed at the time of inspection, recommend sealing along wall, or any settled areas. Over time, settlement can cause water penetration at the house wall. A structural engineer is recommended to inspect the SW porch corner post and foundation. Due to conditions observed, recommend further evaluation by a licensed structural engineer.

Porch north side minor cracking.

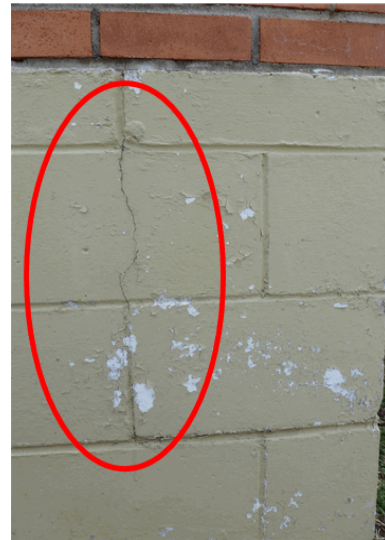
Minor cracking at north corner of front porch.

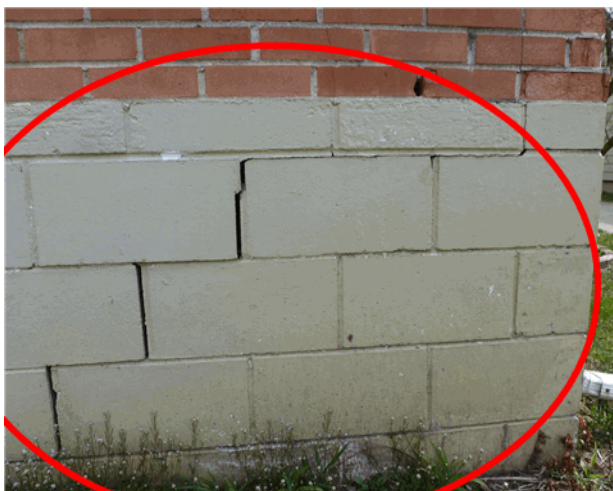
Front SW corner major crack and settling.

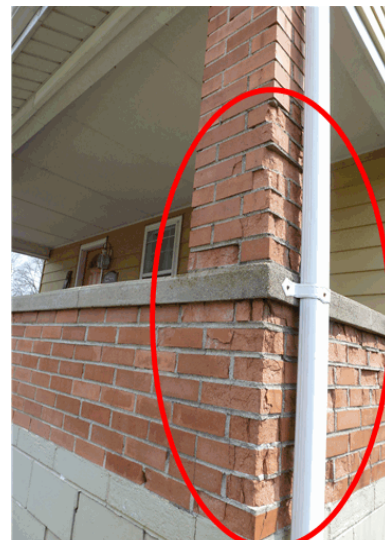
Settlement has occurred please contact structural engineer to determine structural integrity.

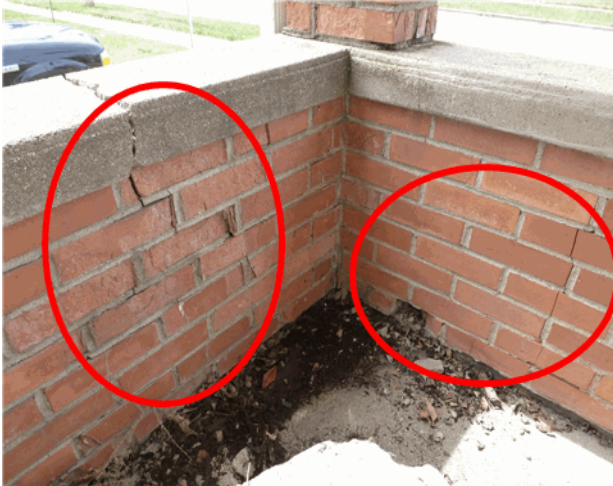
Front porch brick settling and deteriorating.

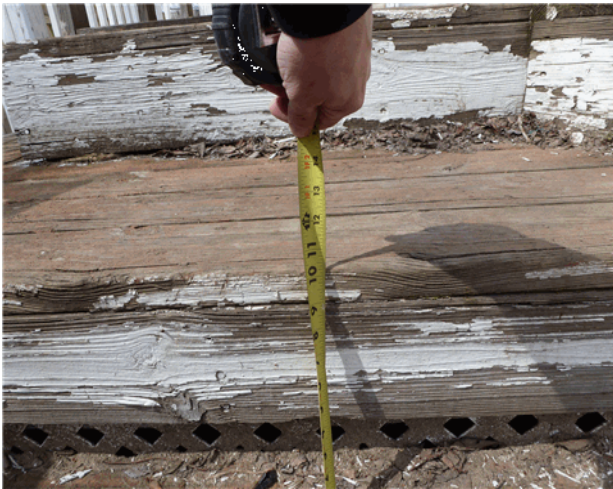
Cracking and / or deterioration were observed to the wood surfaces. The patio surface was raised or settled causing a minor tripping hazard. These should be repaired for safety.

Top Step height 10 1/4" is considered a trip hazard

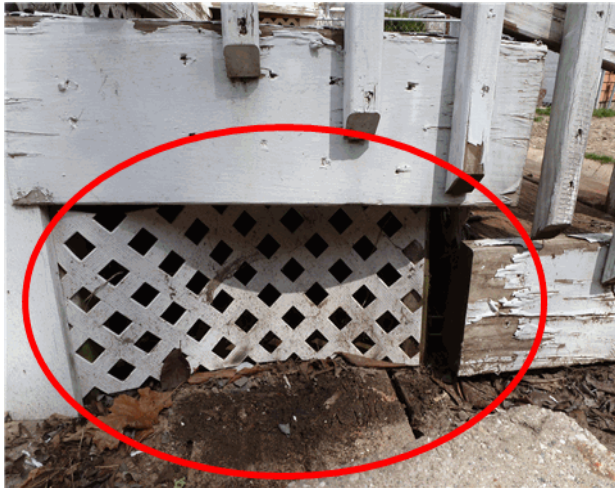
Bottom lattis damaged

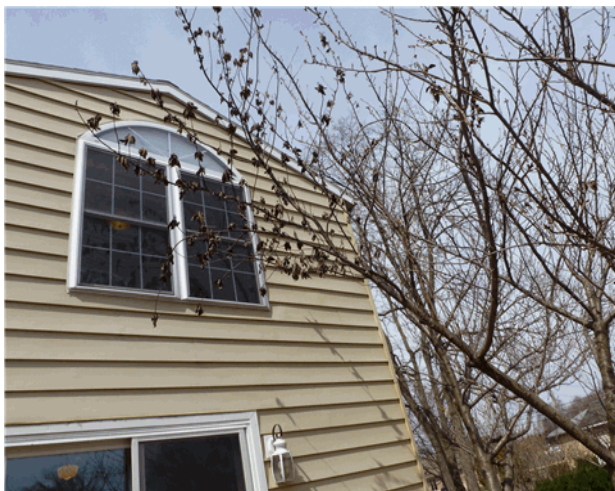
The visible and accessible portions of the exterior wall coverings appeared to be in service Damaged siding was observed at top left corner of the front. Due to conditions observed, further evidence may exist in areas not readily visible or accessible. Water penetration may have occurred. ble condition at the time of the inspection. Large tree or trees were too close at the of the house. These trees may need to be removed to reduce the possibility of damage to the foundation, siding, and / or roof.

Trees are close to the house

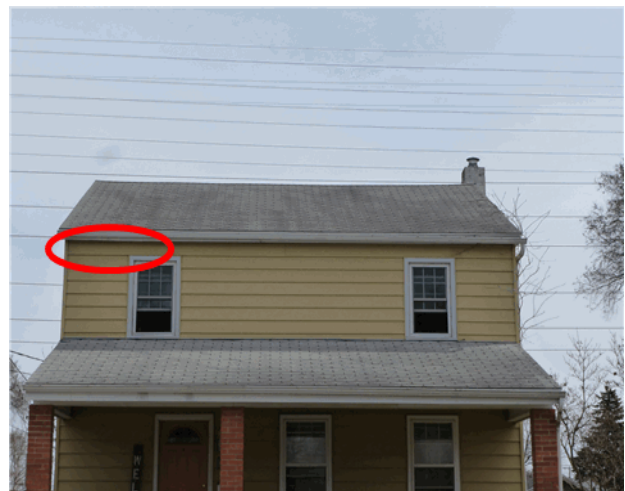
Siding needs repaired to prevent insects and weather from entering building.

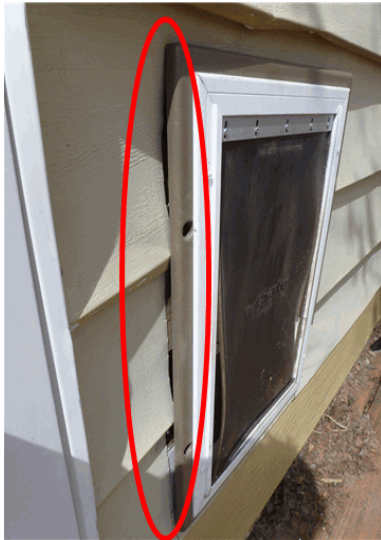
Dog door on the rear of the house is not sealed around the frame. This could be a place for water to penetrate the building.

Pet door not sealed insects and elements can enter the building.

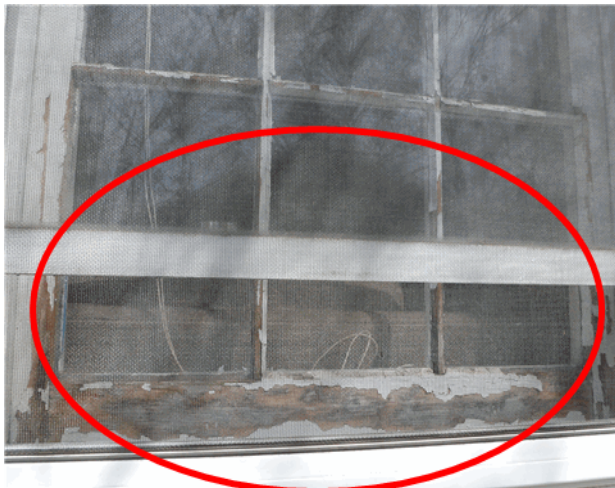
The window caulking, putty and glazing compound was cracking with some deterioration observed. Exterior frame weathering and some deterioration was observed. Recommend repairs / maintenance as needed. Water penetration may have occurred. The original windows are peeling paint. The vinyl replacement windows are peeling paint around the exterior blind stop. Storm window on the rear has a damaged screen.

Peeling paint observed in every window.

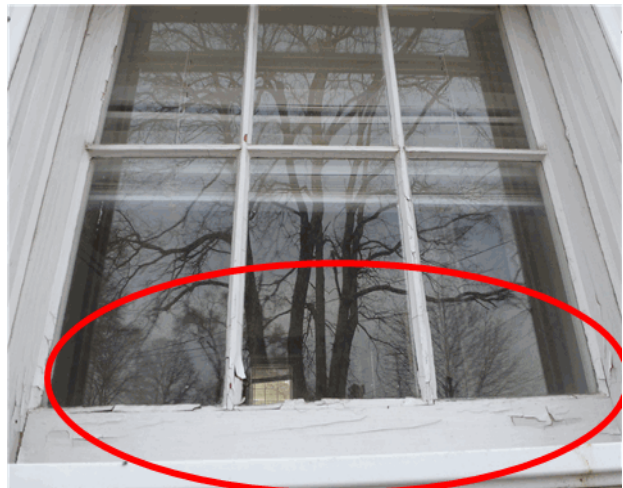
Exterior window glazing deteriorated and peeling paint

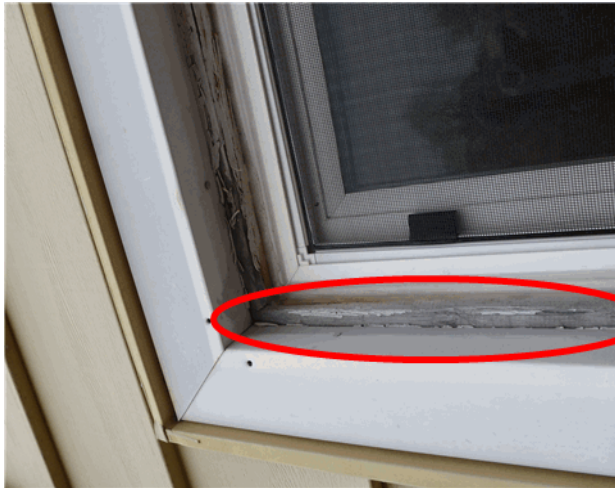
Exterior blind stop peeling paint on vinyl replacement windows.

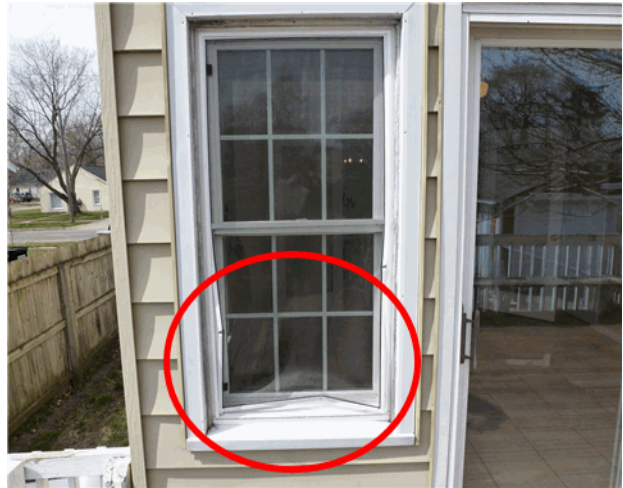
Damaged Screen Rear elevation

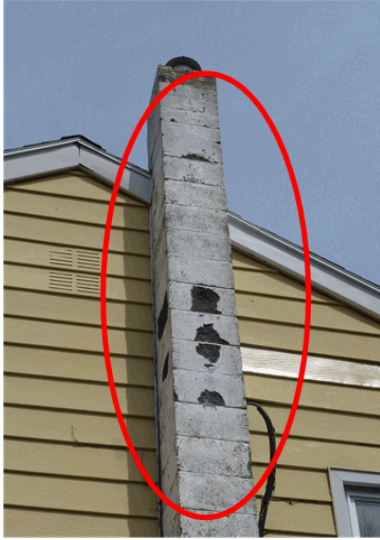
Recommend repairs as needed. The chimney showed signs of settlement cracks and or separations. Sealing is needed between the chimney and the wall. Water penetration may have occurred. Further evaluation would require the removal of siding, which is not performed as part of our inspection. Due to height and / or conditions observed, chimney was viewed from the ground only using high-powered binoculars. Common cracks were observed at the chimney and / or cap. Recommend all cracks be sealed and / or re-pointed as part of normal maintenance to prevent widening of cracks.

Deteriation on the concrete block

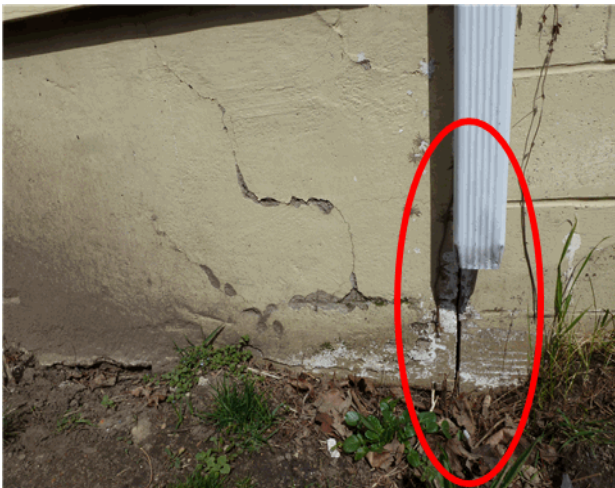
14) Gutter & Downspout Conditions R Splash blocks were missing. Recommend installing splash blocks and 90 degree elbow to reduce soil erosion.

Downspout needs to be diverted away from the structure

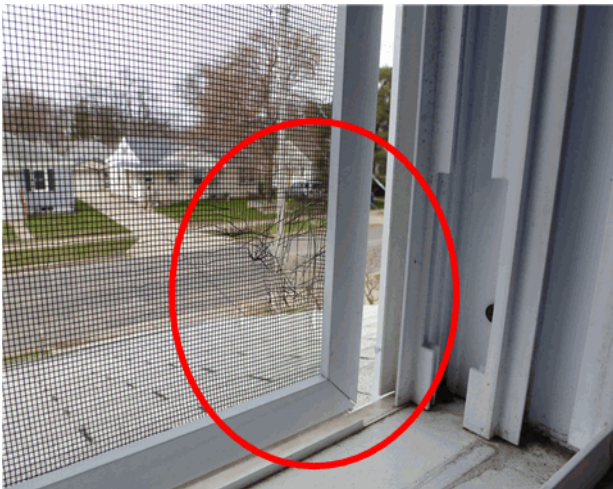
Some of the window screens were missing or not installed at time of inspection. Some of the window screens were ripped and / or torn.

Bedroom 1 screen torn

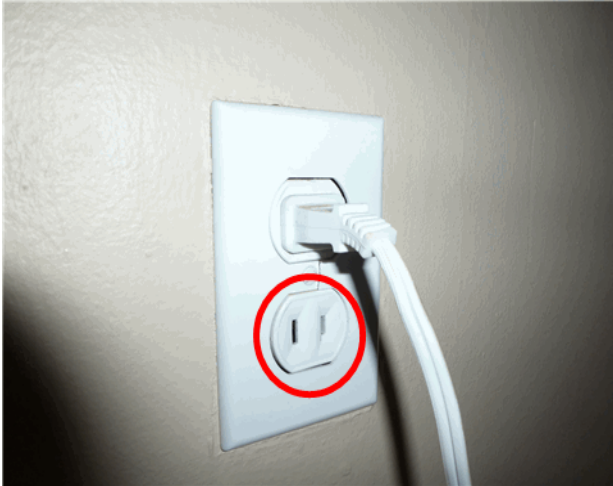
It is suggested that a "Licensed Electrical Contractor" be contacted for further evaluation and repair. Living room electrical receptacles have no ground. Dining room electrical receptacles have no ground. Sun-room electrical receptacles have no ground. Sun-room smoke detector missing. Bedroom one electrical receptacles loose. Master-bed electrical receptacles loose.

No ground on living room electrical outlets

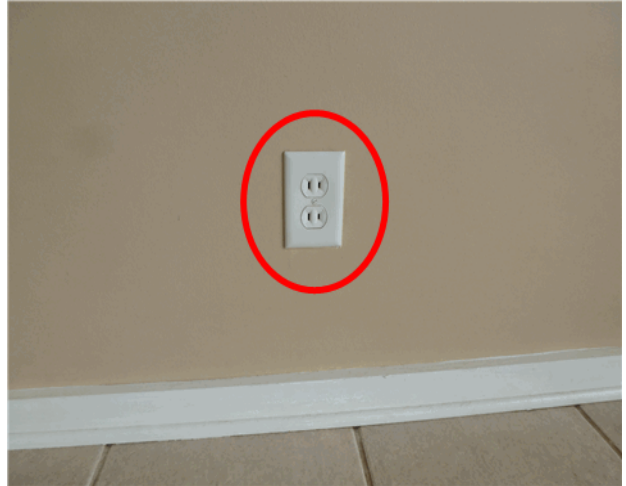
Sunroom electrical receptacles do not have a ground.

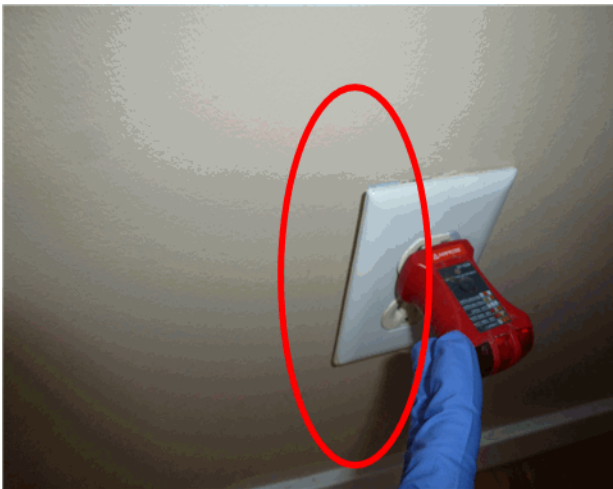
Bedroom 1 outlet loose.

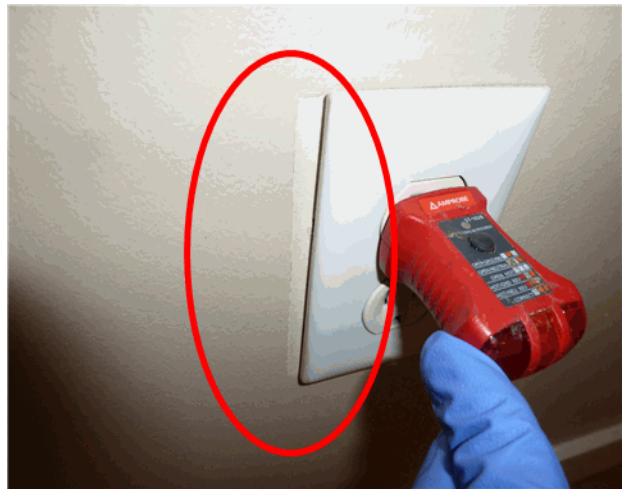
Bedroom 2 electrical receptacle loose

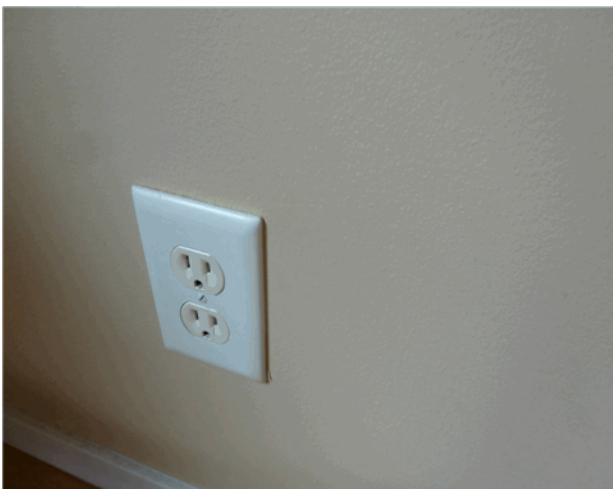
Masterbed electrical receptacle loose.

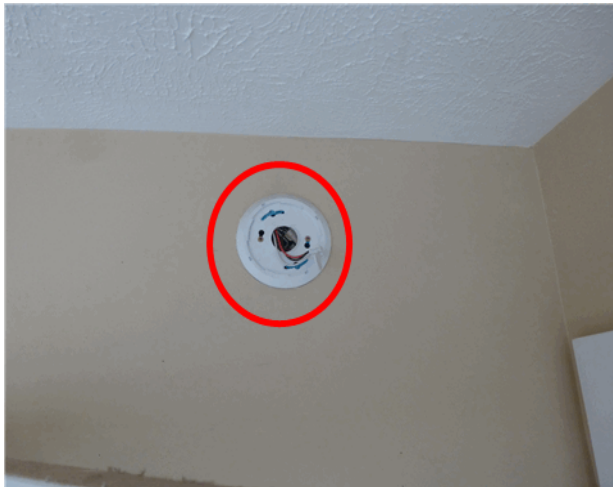
Sun-room smoke detector missing.

Rear Sunroom smoke detector missing.

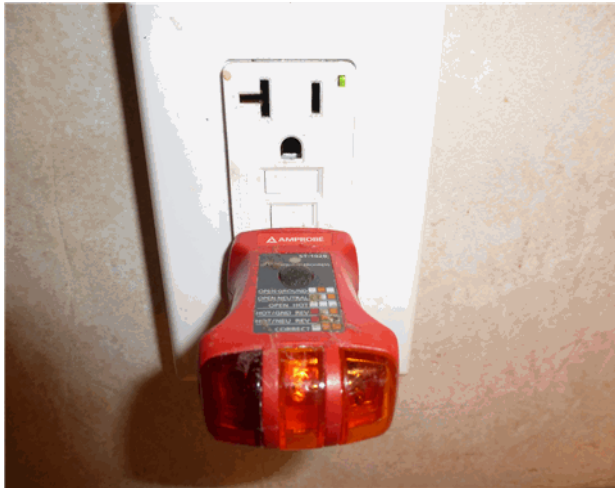
- 38) Kitchen GFIC Electrical Outlets** S Due to conditions observed, we recommend further evaluation of ALL wiring within the home and / or repair as needed by a licensed electrician prior to close. GFIC electrical outlet on the right side of kitchen sink does not provide a ground fault it has an open ground condition. Recommend repairs as needed.

Open ground on GFIC

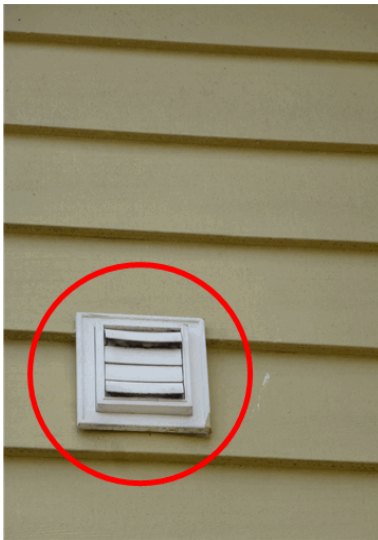
Bathroom vent needs repair on the exterior. Appears Serviceable
Recommend maintenance as needed.

Its recommended to clean vent and fix louvers to prevent water leak

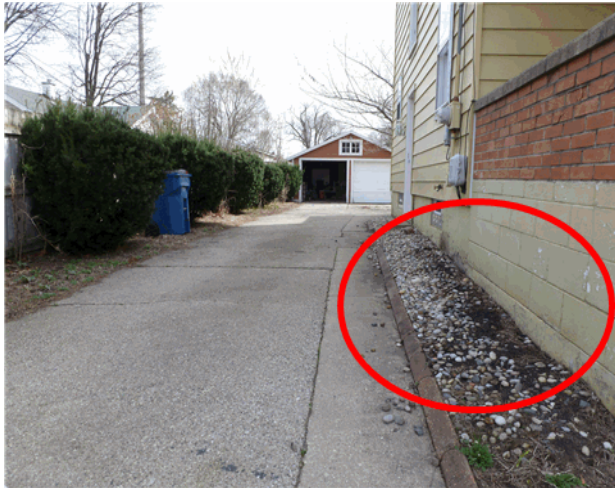
The foundations exterior wall has chipped paint. There were common settlement type cracks and nail pops observed to the interior walls. Although these conditions are common in most homes, client is advised to monitor cracks for future movement.

Weather exterior basement wall have loose paint and mortar.

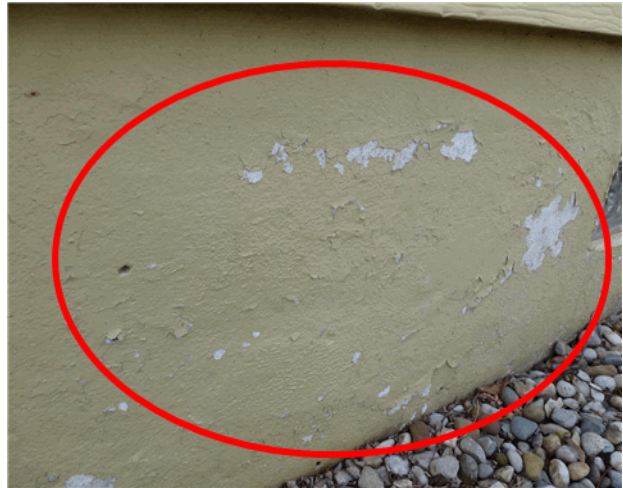
Loose paint at exterior basement walls.

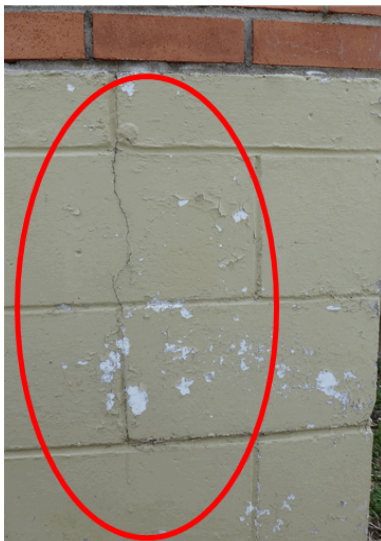
Minor cracks and peeling paint on north side foundation wall.

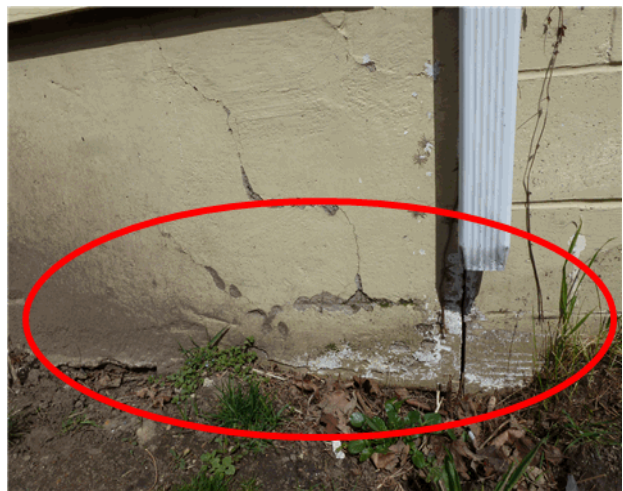
South side exterior basement wall cracked mortar and peeling paint.

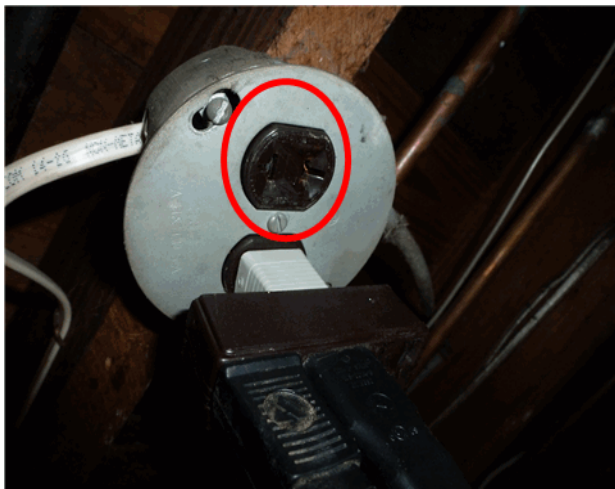
S	It is suggested that a "Licensed Electrical Contractor" be contacted for further evaluation and repair. The GFIC (ground fault interrupter circuit) receptacle did not respond to the inspectors (external) trip test device at the laundry room west wall. Replacement and / or repair is needed. Recommend further evaluation and / or repair by a licensed electrician prior to close. Outlet above washer has no ground.
---	--

Electrical outlet above cloths washer has no ground.

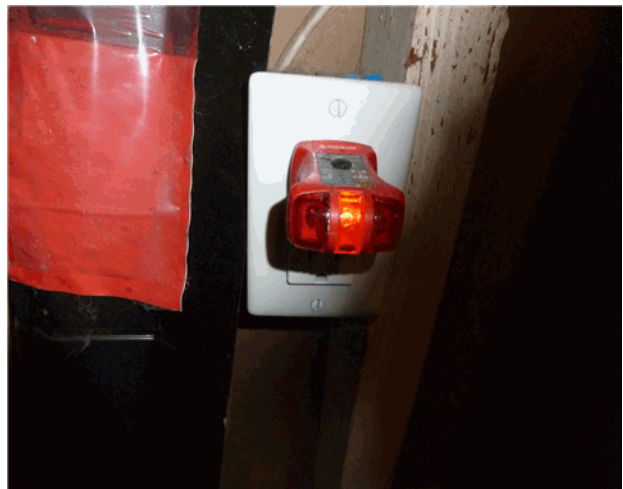
Basement laundry room GFIC failed. Outlet has an open ground.

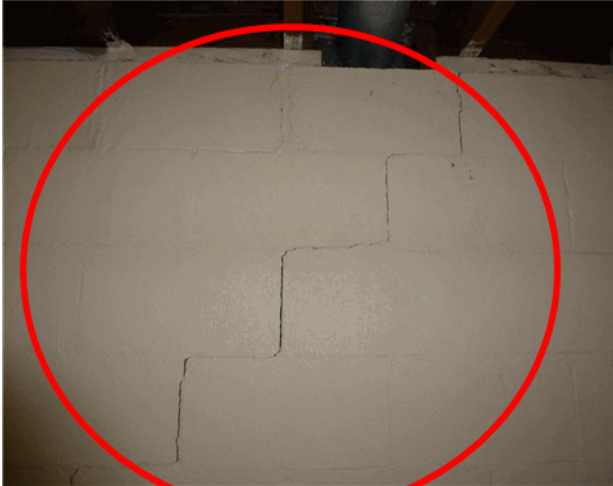
Minor foundation cracks in laundry room area. It is suggested that a "Licensed Masonry Contractor" be contacted for further evaluation and repair.

Laundry room exterior wall cracks.

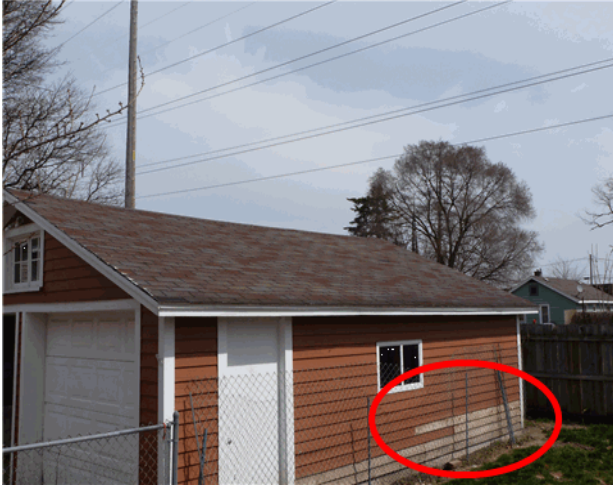
Garage repaired siding needs to be sealed from the elements.

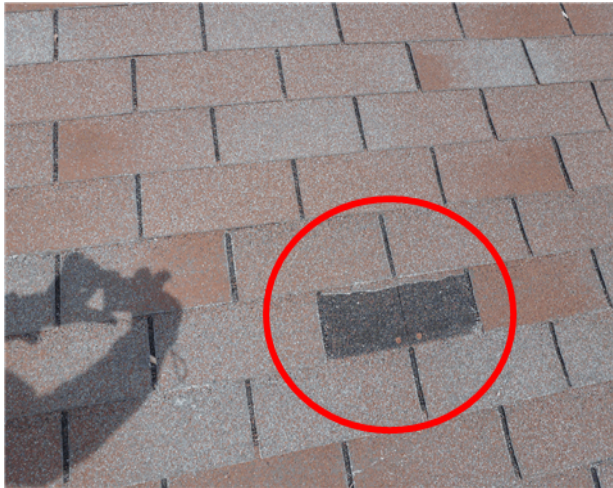
Damaged or missing shingles were observed at both sides of the gable roof. Recommend further evaluation and repair as needed by a qualified / licensed contractor. The inspector can not offer an opinion as to whether the roof leaks today unless it is moderately raining at the time of inspection. Client should obtain full disclosure / history information from the seller prior to close. Moss covering was observed on the roof. While mostly cosmetic and not immediately harmful, this condition can indicate a moisture related condition. This condition may also be seasonal depending on tree / leave coverage and the position of the sun during the changing seasons. Client should consult a roofing contractor or roofing supply company regarding maintenance related issues and products that can reduce this condition.

Missing shingles on south side of garage roof.

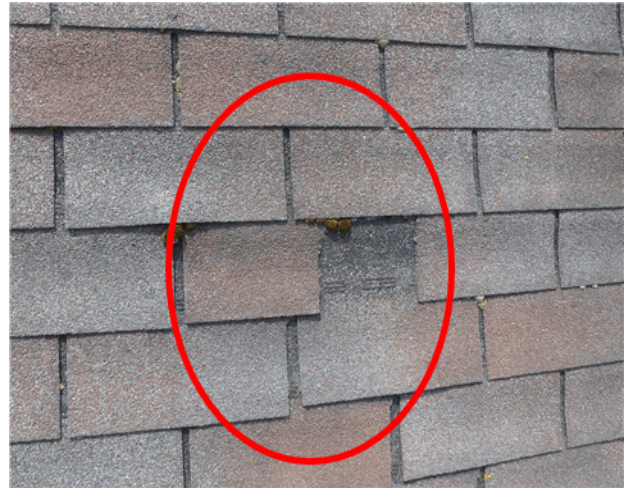
Missing shingle of south side garage roof.

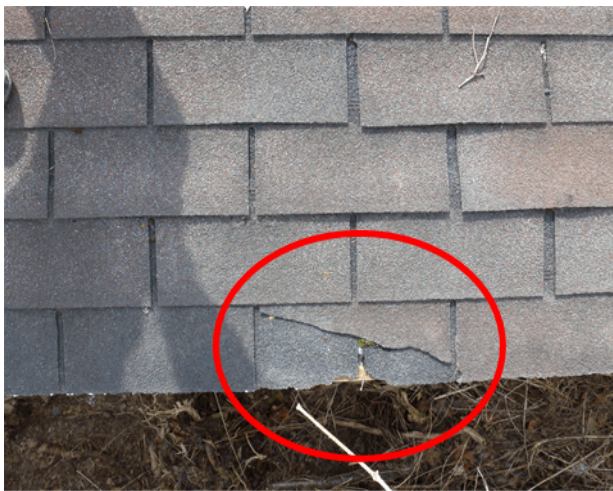
Damage on the eave of the north side garage roof.

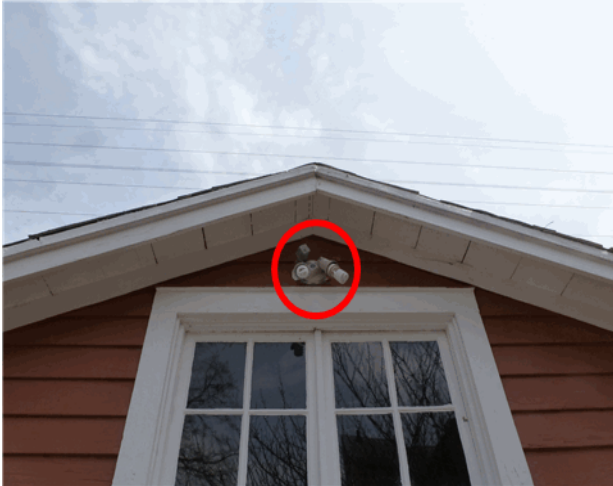
Garage outdoor light bulbs not rated for exterior use.

Garage light bulbs not exterior rated.
