Inspection Report

2287 Waldon Rd
Grand Rapids , MI 49505

1 Report Information

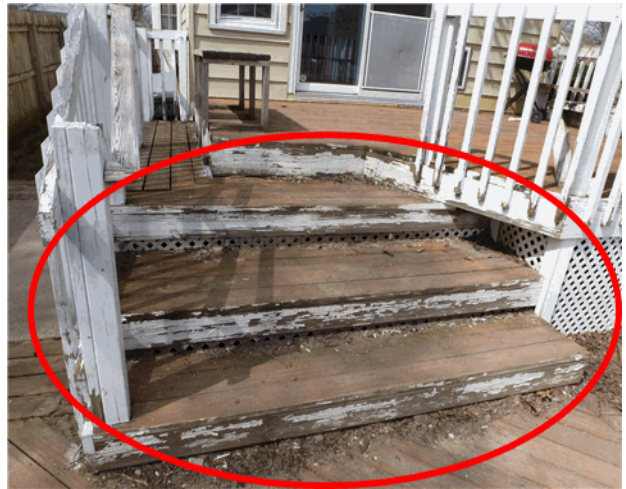
Top Step height 10 1/4" is considered a trip hazard

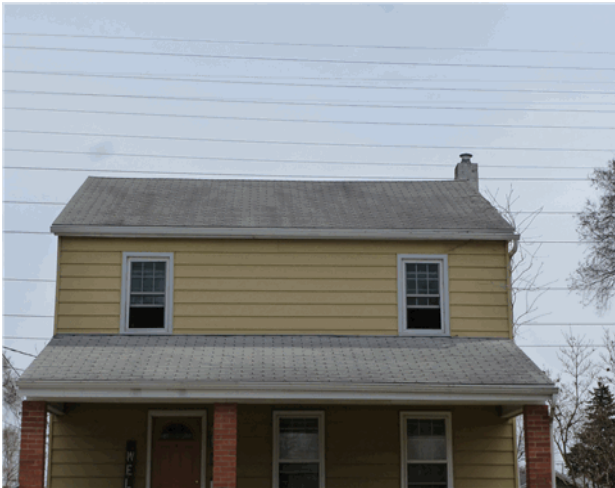
12) Roof Covering Condition AS The general condition of the roof shingles shows signs of weathering and aging. Although replacement does not appear to be necessary at this time, we recommend maintenance be performed on a regular basis with annual inspection by a qualified roofing contractor.

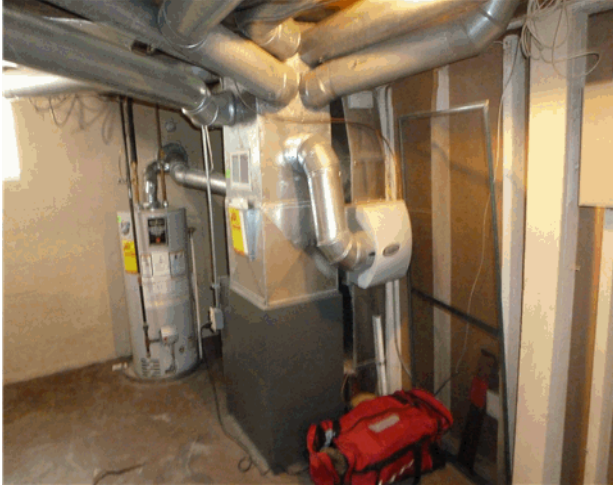
16) Unit Conditions AS The heating system was operational at time of inspection. This is not an indication of future operation or condition.

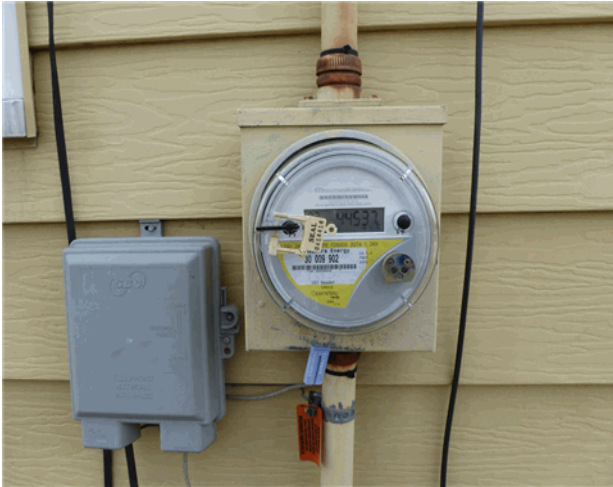
20) Electrical Service Conditions AS The main service entry appeared to be in serviceable condition at the time of inspection.

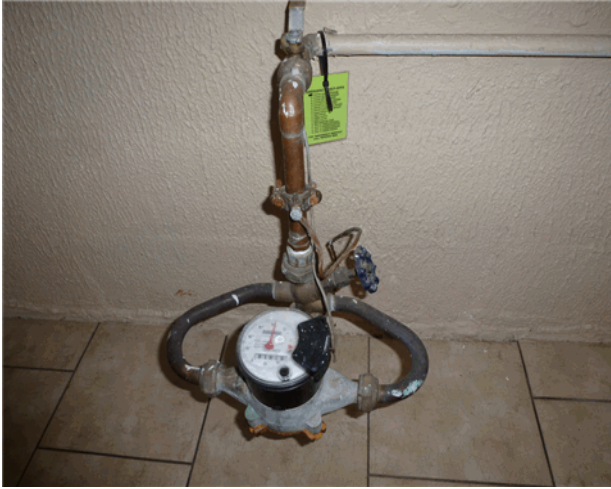
23) Main Line & Valve Conditions AS The visible portion of the main pipe and valve appeared to be in serviceable condition at the time of the inspection.

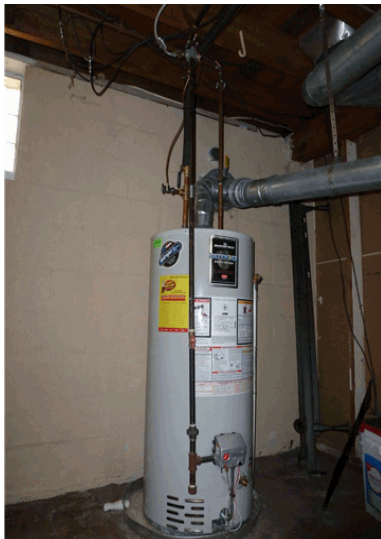
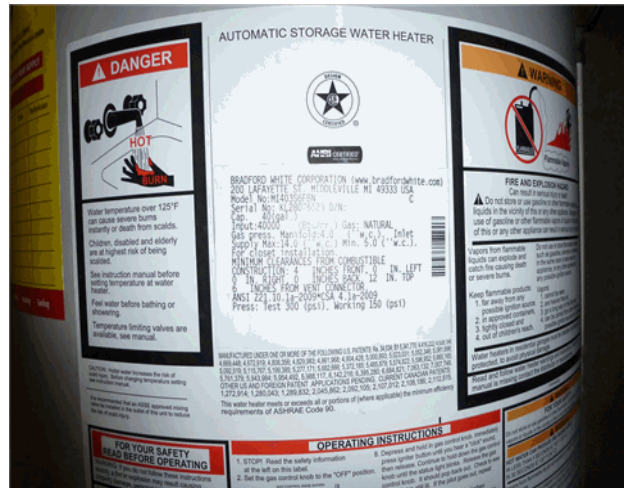
26) Water Heater Conditions AS The water heater was operable at the time of inspection. This does not however guarantee future performance, operation, or condition.

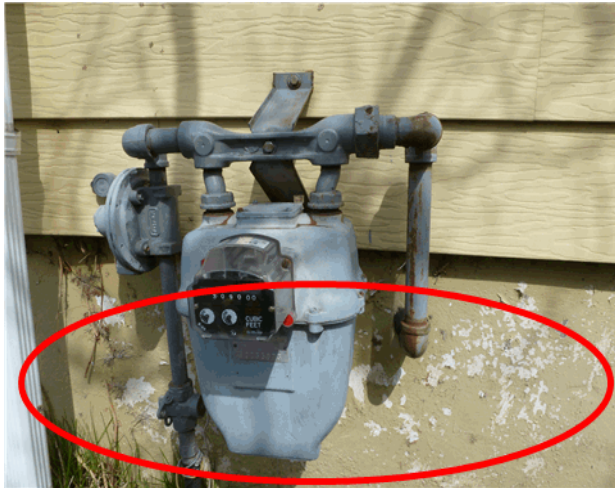
South side exterior basement wall cracked mortar and peeling paint.
